## Final Random Inspection Report

Client Ref. No.: 7019 | Report No.: 7019031 | Date: June 24, 07 | Total page: 15

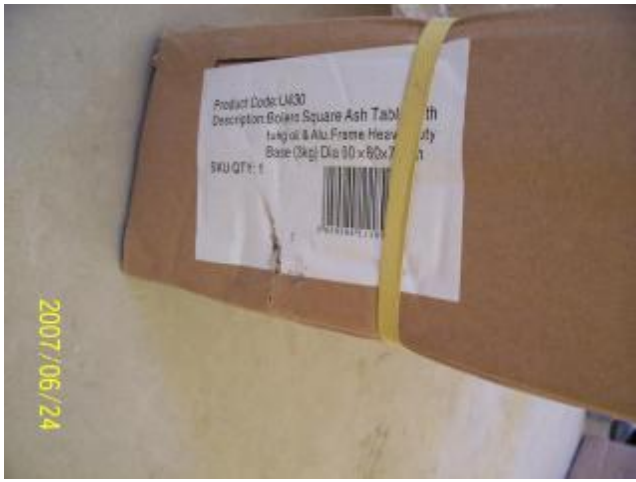
| Item No. | Check Qty | Defects Description | Cri | Maj | Min |
|---|---|--|---|---|---|
| U430 | 35 | Master carton SKU damaged. | | | 1 |

| <p><b>Label damaged:</b></p> <p>A photograph of a cardboard box with a white label that has been partially torn and damaged. A yellow date stamp '2007/06/24' is visible in the bottom left corner.</p> | <p><b>Glue mark on base:</b></p> <p>A close-up photograph of the metal base of the table, showing a red arrow pointing to a small red mark on the surface. A yellow date stamp '2007/06/24' is visible in the bottom right corner.</p> |

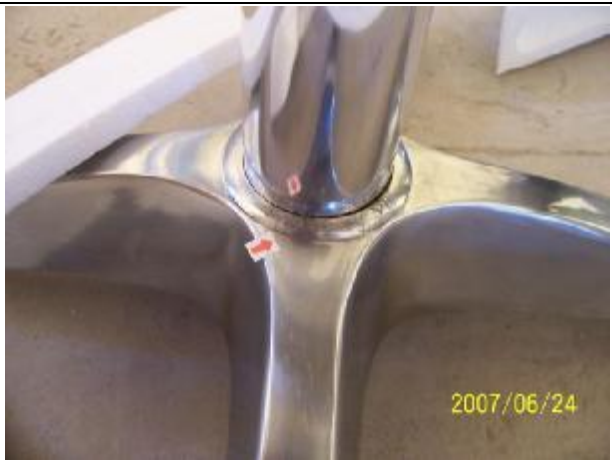
| Item No. | Check Qty | Defects Description | Cri | Maj | Min |
|---|---|--|---|---|---|
| U424 | 19 | Glue mark on base. | | | 1 |

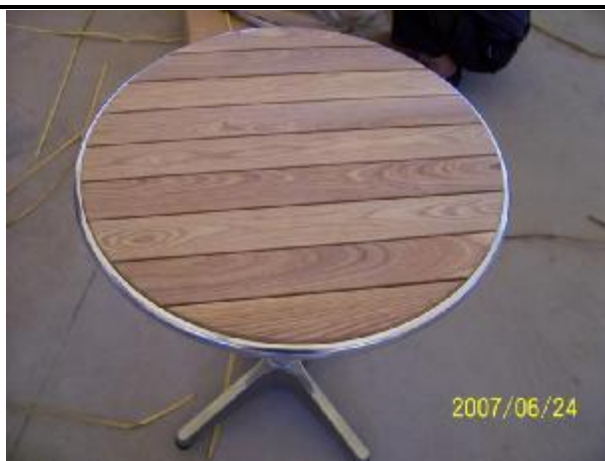
| Item No. | Check Qty | Defects Description | Cri | Maj | Min |
|---|---|--|---|---|---|
| U428 | 16 | Wood poor assembly. (excessive gap between wood and rim) | | 1 | |

**Excessive gap between wood and rim:**

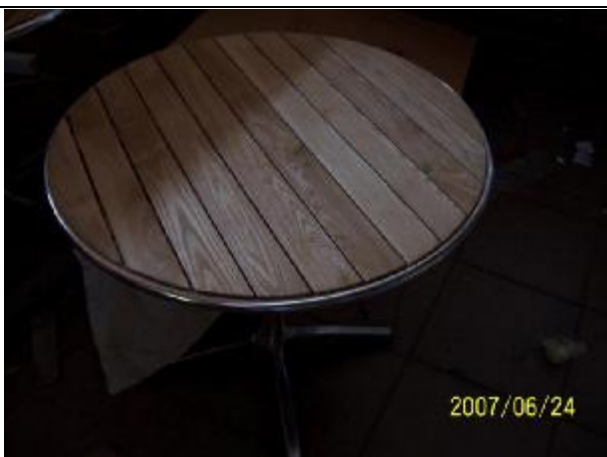
| Item No. | Check Qty | Defects Description | Cri | Maj | Min |
|---|---|--|---|---|---|
| | | Flash mark at bottom of table. (screw position) | | 1 | |

**Flash at rim: (bottom of table)**

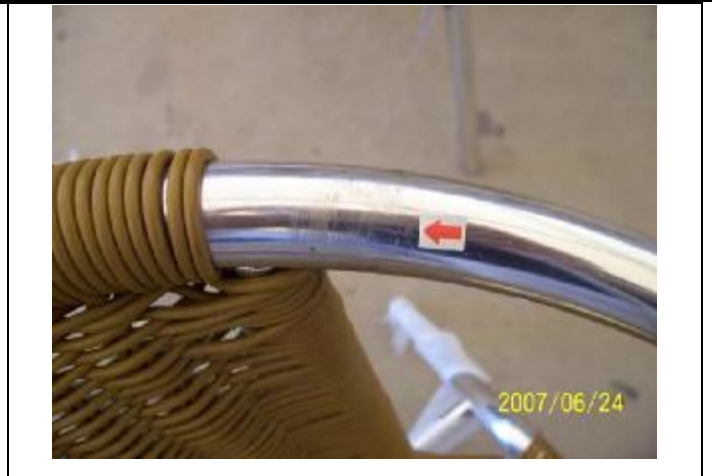
| <p><b>Special remark:</b> 1. For U421, no product ready for inspection for this order.<br/> 2. For U429, half-product finished, but not packing for inspect, only pack one carton and 6pcs assembly for check this time.<br/> 3. For U422, Some of PE protect sheet jammed at product's joints, factory must be improve it next time.<br/> 4. Some of carton with damaged mark and deformed, factory must pay more attention to this question.<br/> 5. No approval sample for compare during this inspection, so the result is pending.</p> | | |

| Item No. | Check Qty | Defects Description | Cri | Maj | Min |
|---|---|--|---|---|---|
| | | Something jammed at the joint. (protect PE sheet) | | | 3 |

**Something jammed at joint: (protect PE sheet)**

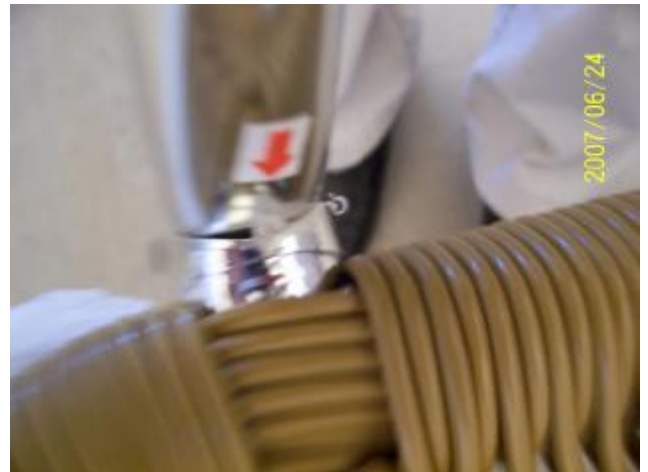
| Item No. | Check Qty | Defects Description | Cri | Maj | Min |
|---|---|--|---|---|---|
| U422 | 55 | Glue mark on surface. | | | 1 |

**Glue mark:**
